Rebuilding an Artizan Model XA Pump/Reservoir Assembly

Scotty Greene

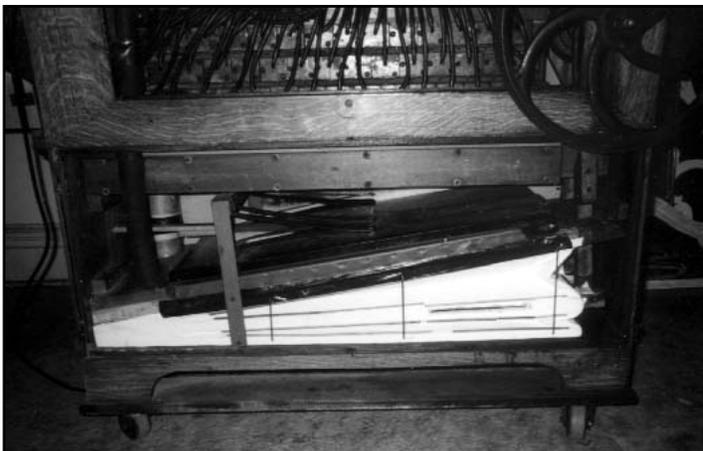
When we first pulled the lower back cover off, we noticed that the pump seams were reinforced with duct tape and staples—not a good sign.

Figure 2. The Style “X-A” pump as it appears before restoration.

When we turned it on it was evident that the interior stiffeners had come loose, as the sides of the pump ballooned on every power stroke. Air was coming through most of the duct taped seams, and of course the machine would not even attempt to play.

The first and most obvious thing that needed to be fixed was the main pump and reservoir assembly (Figure 2). Neither Martin nor I had ever done one, so we thought it would be prudent to ask for advice. We checked with Dr. Bill Black who kindly sent us a 2 page outline of how to do it. His closing remark “Pumps are tough!” stayed with us through the whole process, and was he ever correct!

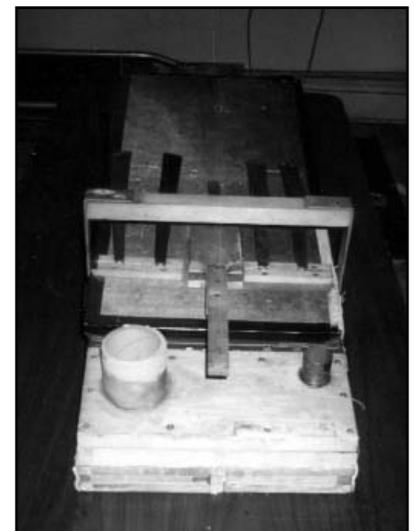
Figure 3. View of pump from air discharge end after removal from organ.

After the pump assembly is out of the machine there are a lot of exterior attachments to remove. Take a bunch of pictures and make good notes (Figure 3). Be especially careful to make dimensional notes for the bridge that retains the springs, those screw holes will be covered by the new leather and you will have trouble finding them when reassembling if you don’t have good dimensional notes.

As for the rest of the items, just use care and label everything. Put “match marks” on the parts as you disassemble to help with which way around things go. Look out for different length screws and note where they came from. You cannot make too many notes at this stage. You may think you will remember, but you won’t. (Note the liberal but failed use of duct tape on our patient.)

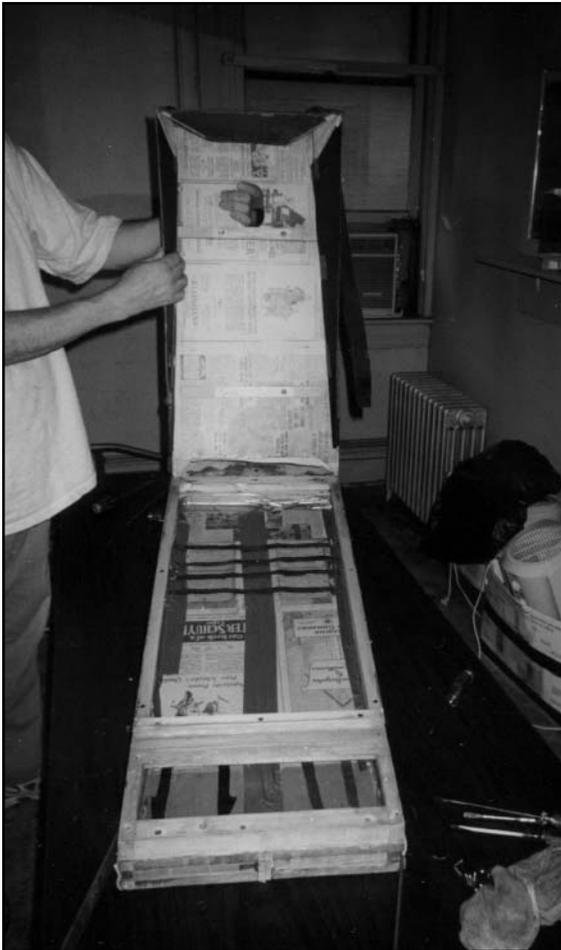
Figure 4. The frame for the pump's reservoir.

In **Figure 4** we are looking at the frame for the reservoir, which is glued to the top of the pumps. There are actually two frames shown here, one on top of the other. There is the top one that the bottom edge of the reservoir material glues to, and a lower one that extends to the end of the air collector area and is attached to the top of the pumps. They do not need to be separated if you can get them off in one piece. There are a couple screws under the top frame into the pump that are hidden from view and have to be hacksawed off if you want to take the two frames off as one. Drive a knife into the joint and say a small prayer, and you may get lucky and not totally destroy anything. Of course you will have to repair whatever damage you did to the pieces when getting them apart.

The next step is to take the reservoir off the top of the pumps. Make a note as to the fully opened dimension. Try a hot air gun on the leather to wood joints, and try to save the leather for use as a pattern for the new cover. When you get it off, the view will be like this (there was even duct tape inside the reservoir!).

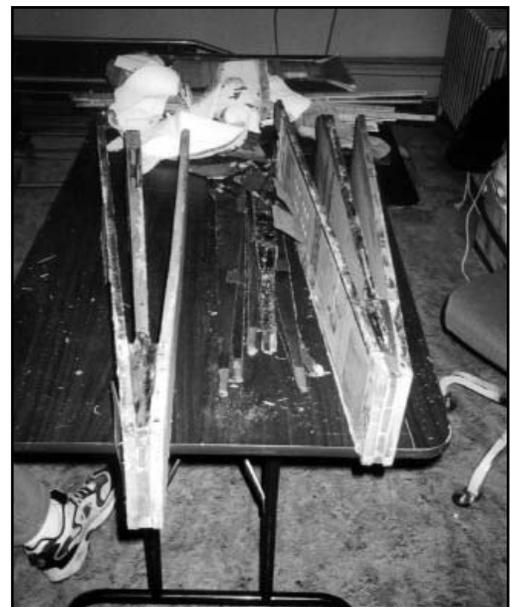
Figure 6. The disassembled pressure pumps detailing the hinges and centerboards.

determine the overall assembly width, and that must be correct to match up with the reservoir base. Separate the two pumps. You may have to saw your way through the strips to get the two separated. Watch out for the side wires, and try not to cut up the leathers when sawing. Measure the position of the side wires, and take them off. Remove the leather, use heat or care and try to save at least one for a pattern (**Figure 6**).

You will have to clean all traces of old glue from the wood where the leather is glued in order to get a proper bond when attaching the new leathers.

If the hinges are good you are in luck. If not then mark the centerboards so that you can get them back the same way.

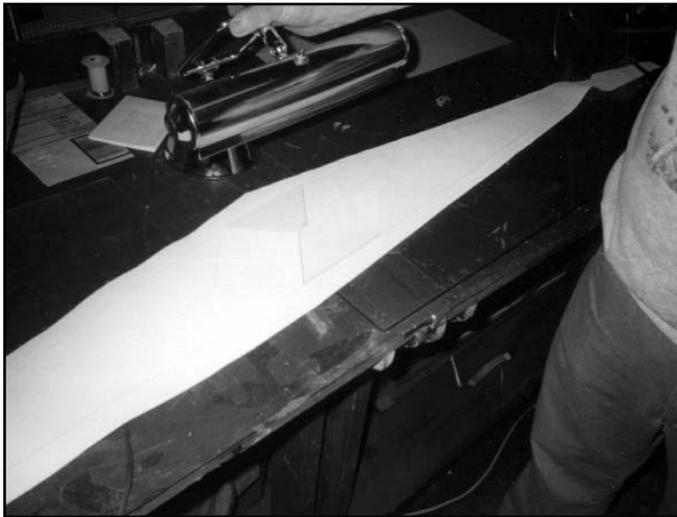
Figure 7. The trimmed leather ready for the internal stiffeners to be glued into place.

If the internal leather stiffeners are shot you will have to make new ones. After a lot of hunting around we settled on material used for picture mats. We used the .060 thick, all cotton fiber, ph balanced acid free style.

The next step is to cut the leather and glue the internal stiffeners in place (**Figure 7**). After determining their correct position outline the area with masking tape before applying the glue to keep the glue confined to the area of the stiffeners. The stiffeners have to be weighted to keep them flat until the glue dries.

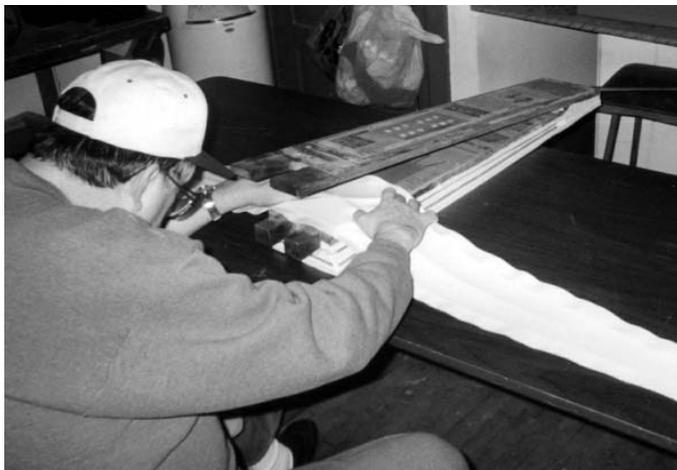
Figure 8. Attaching the leather to the pump boards.

At this point you are ready to attach the leather to the pump frame (**Figure 8**). Start at the open end. Lay the leather out flat and glue one side. Nail down the tack strip.

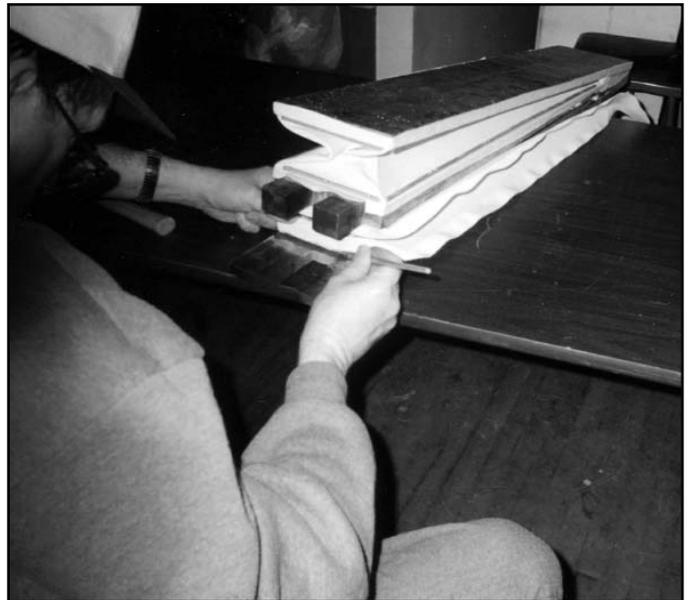
Figure 9. Attached the remainder of the leather to the pump.

Then turn the whole assembly over, fold the sides into their proper position, and glue the other half of the open end. (**Figure 9**).

After that do the sides in whatever sequence seems good to you. You will have to watch out for the tendency of the leather

to move in while you are trying to nail the tack strips. Ideally the base of the stiffeners should touch the wood about $\frac{1}{4}$ inch in from the edge, leaving just room enough for the tack strips. We used $\frac{3}{4}$ inch #17 headed brads, and pre-drilled the new tack strips—the original tack strips were mostly destroyed at disassembly.

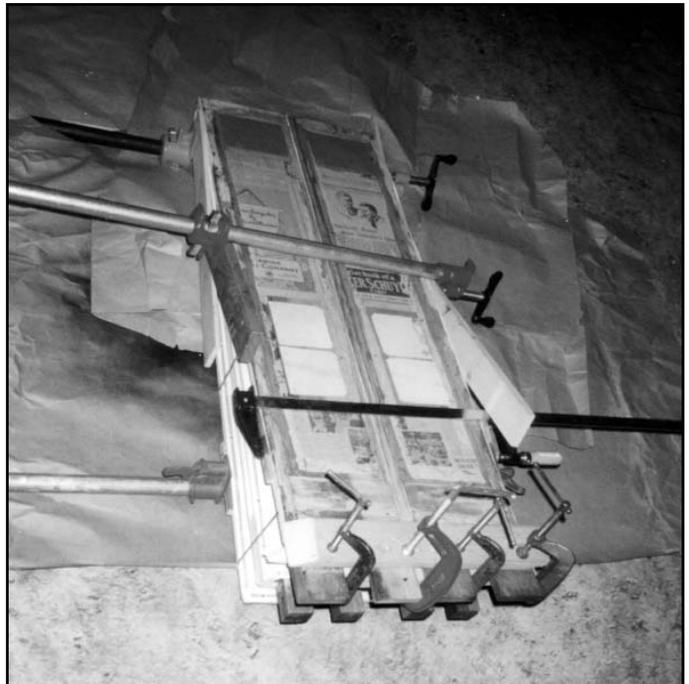
Figure 10. The two pumps being glued back into place.

After you have all the leathers in place then reattach the side wires (you did measure the positions they go in so you could find the original holes after the new leather covered them didn't you?). Then glue and nail the wood strip that go between the two pumps in place. We used silicone caulking to seal and glue the wood strips to the pumps. It is a mediocre glue but a good sealer—the top joint needs to be air tight.

At this point it is a good idea to dry fit the reservoir frame to the pumps just to be sure everything is going to be the right size. If it is not you can add or shave some off the wood strips to get the required alignment. Assuming it all fits the next step is to glue the two pumps together. Again we used silicone caulk for this joint. Use a lot of clamps, and be sure the top edges are held in alignment (**Figure 10**). We clamped a wood strip across to guarantee this.

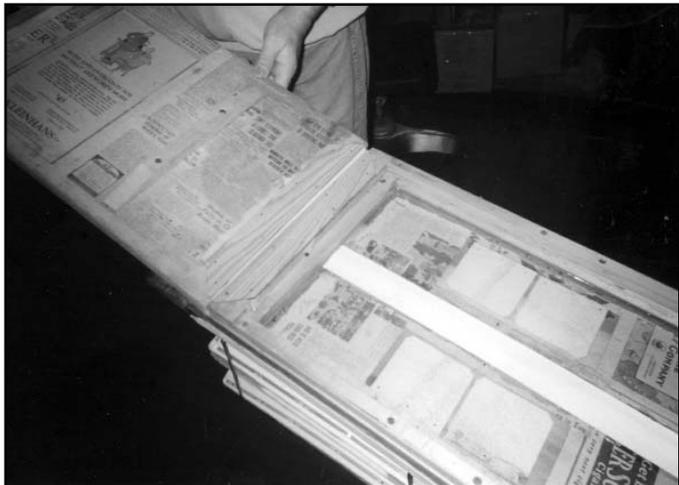
Figure 11. The pumps now have been glued to the reservoir frame and covering the reservoir is the last step.

After the glue/sealer dries you are ready to mount the frame to the top of the pumps (**Figure 11**). Again we used silicone seal as this is another joint which must be air tight. The other benefit we hope will be inherent with use of the silicone is that it can be taken apart without destroying the adjacent wood parts. It is also able to fill the gaps and uneven surfaces caused by damage during disassembly. If you have already sealed/glued the two parts of this frame together you will have to drill two holes on each side for screws that go through both frames and into the pumps. Be careful not to hit the old screw holes or the side wires

With the frame mounted "all" you have left to do is cover the reservoir, and after what you have been through to date this should be a piece of cake. The original on this machine was rubber cloth, and that is what we used.

The joint down the center between the two pumps was originally covered with a leather strip, and even though we were sure the joint was sealed with silicone we replaced the leather strip to be on the safe side.
